Corrosion in refineries

Edited by J. D. Harston and F. Ropital

European Federation of Corrosion Publications
NUMBER 42

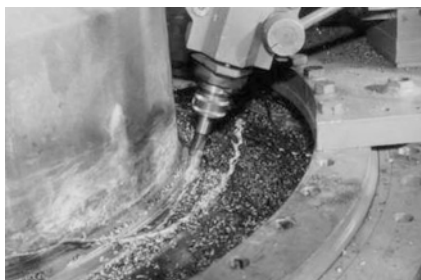
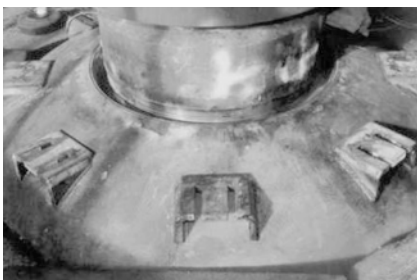
2.16 Removing damaged weld metal and HAZ from inlet nozzle weldment.

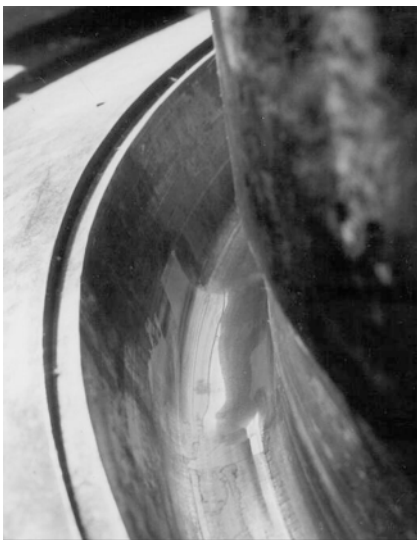
2.17 Nozzle weld profile after damage removal.

crack growth analysis revealed that the existing cracks could grow to a critical size within the proposed three-year run period. Weld repair was thus a priority. An 'A' parameter creep cavitation damage depth profile was deployed to plan the extent of repair (Figures 2.13–2.15). A mechanical machining method was adopted to remove all cracking and cavitation from the weld metal and associated HAZ (Fig. 2.16) Replica checks at the bottom of the excavation were performed to confirm a damage-clear situation (Fig. 2.17).
